Melania Cano  
*Architectural Technician*

## Detached House 2018

New development for a detached house of four floors in Madrid, Spain.

## Tara House 2018

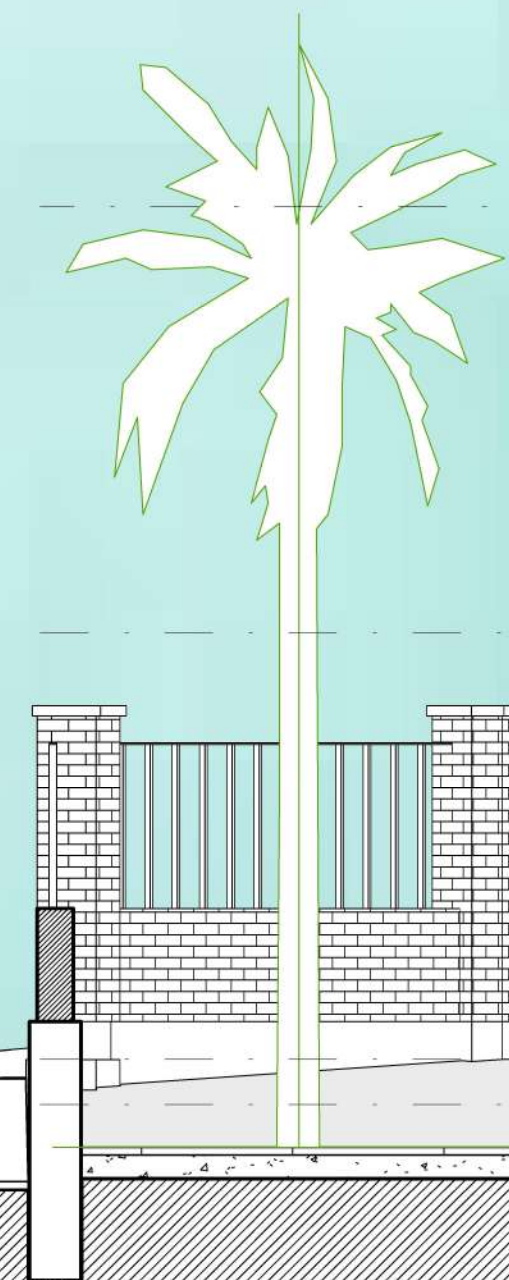
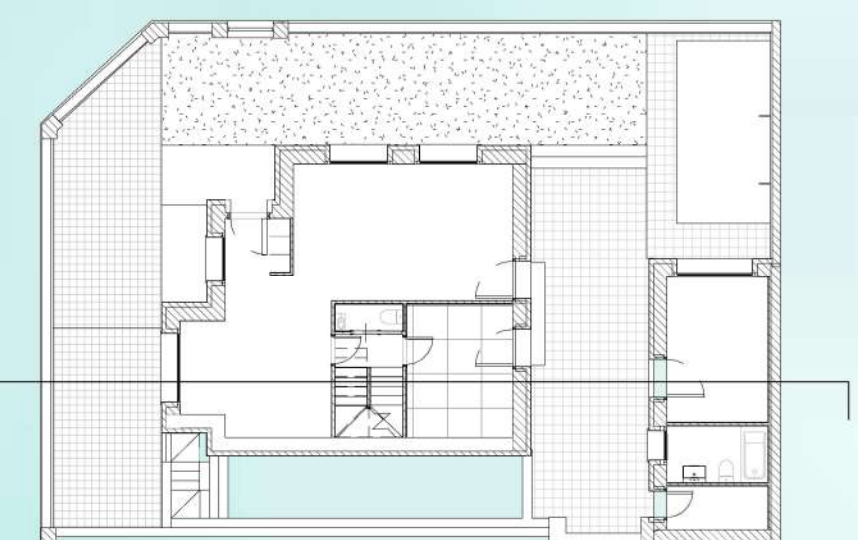
1' SECTION AA  
07 1:50

5.64 - Second floor

2.82 - First floor

0.00 - Ground floor

-0.30 - Swimming pool level

-2.82 - Basement floor

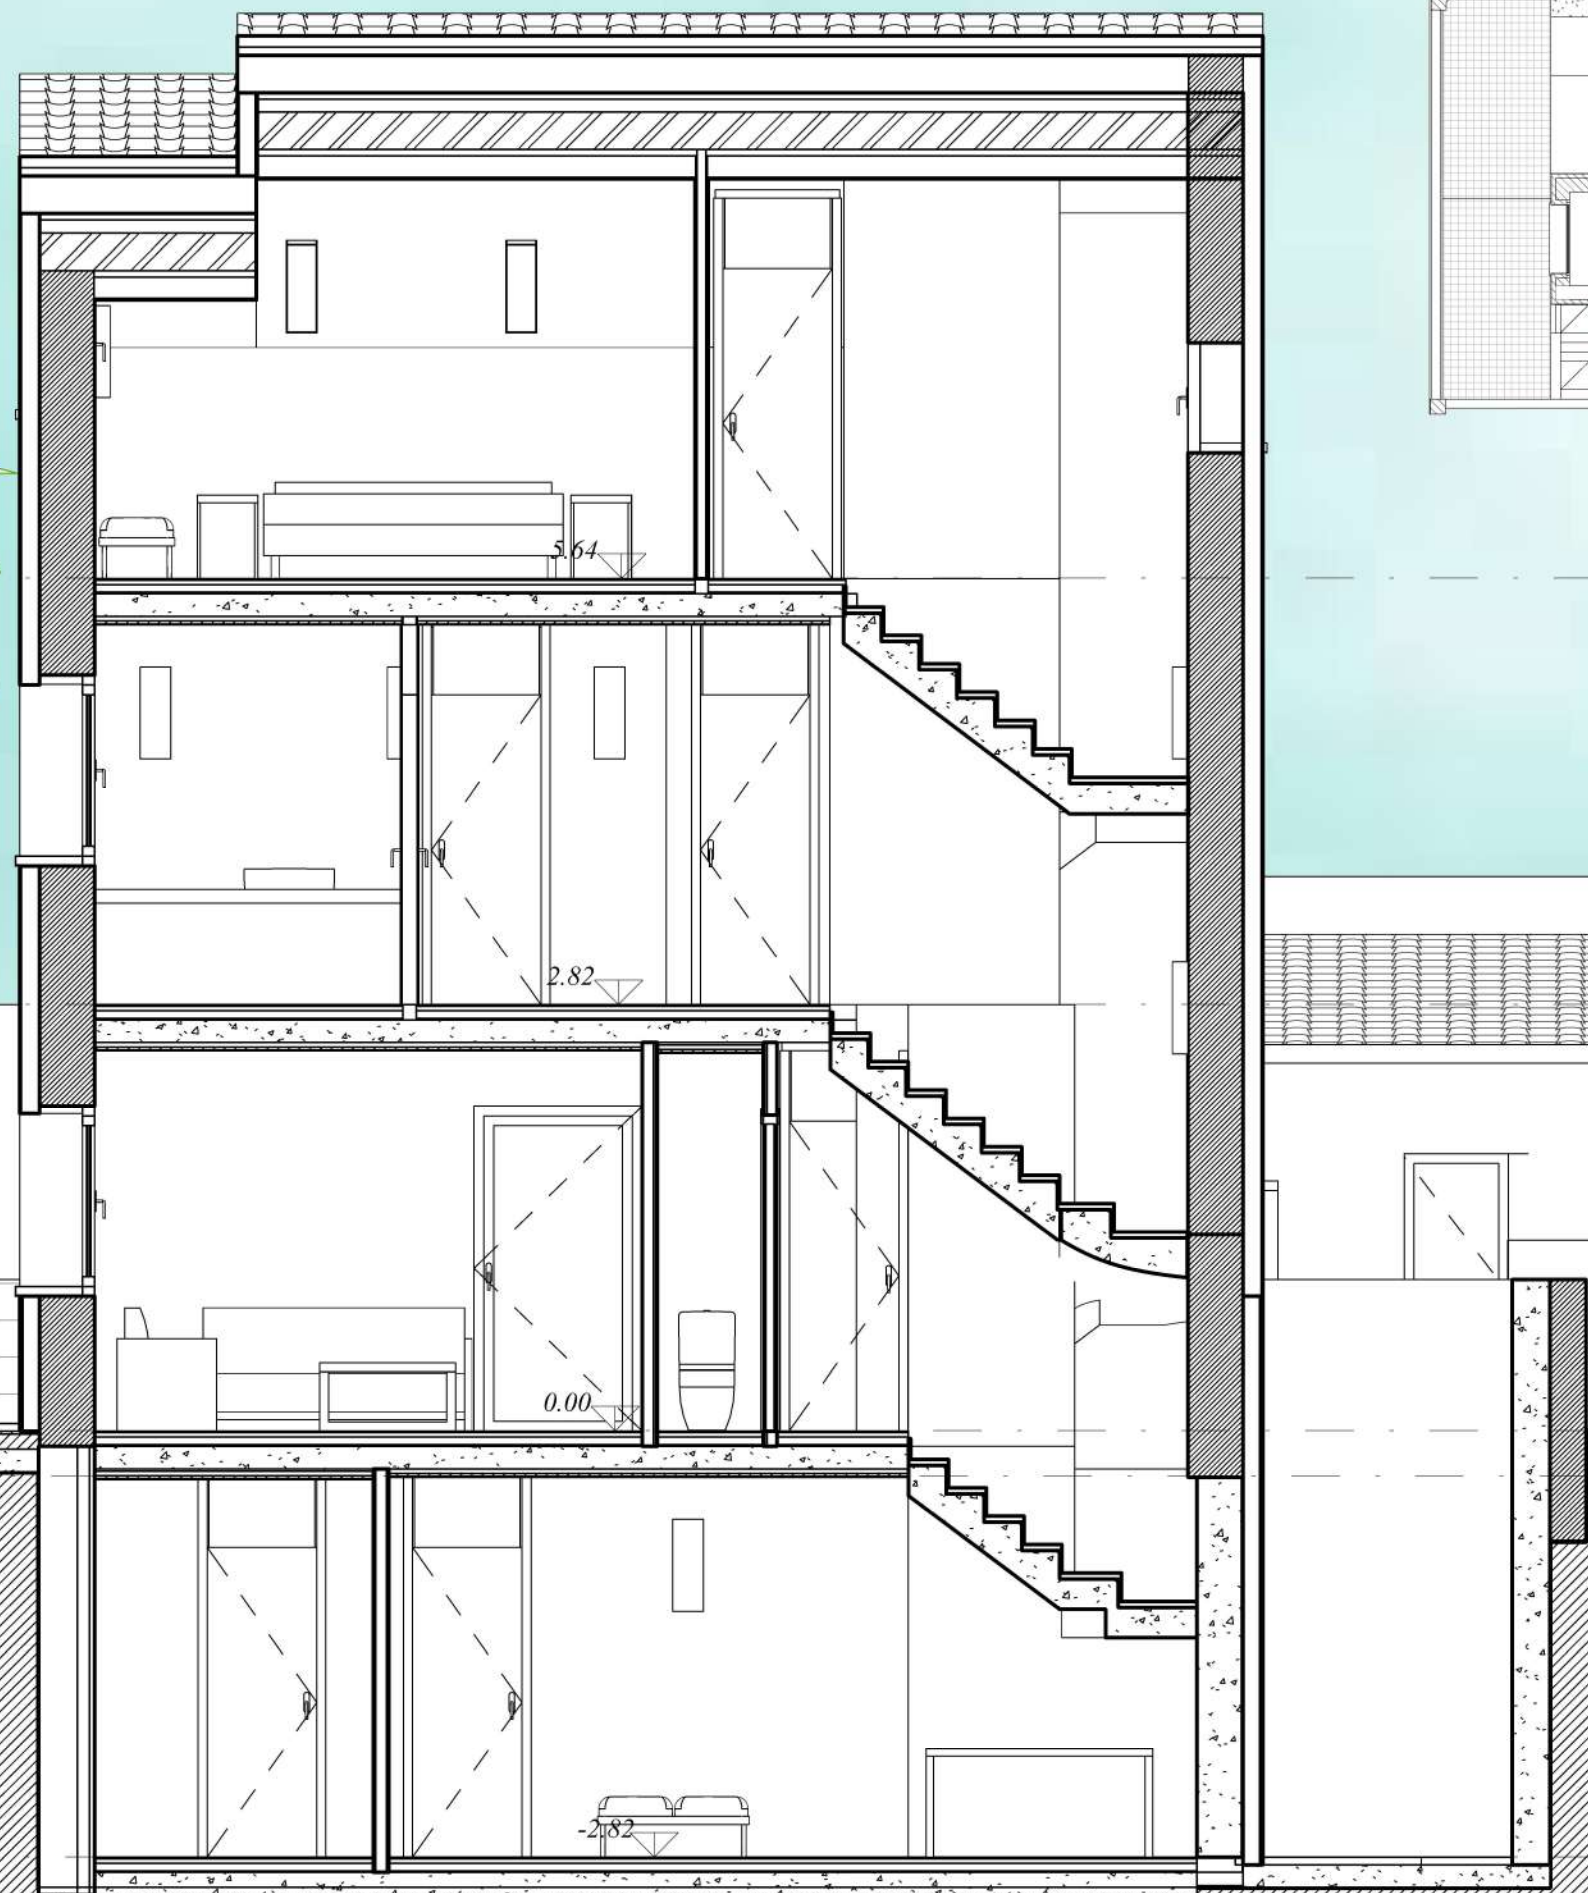
1  
08 SECTION BB  
1 : 50

Second floor - 5.64

First floor - 2.82

Ground floor - 0.00

Swimming pool level -0.30

Basement floor -2.82

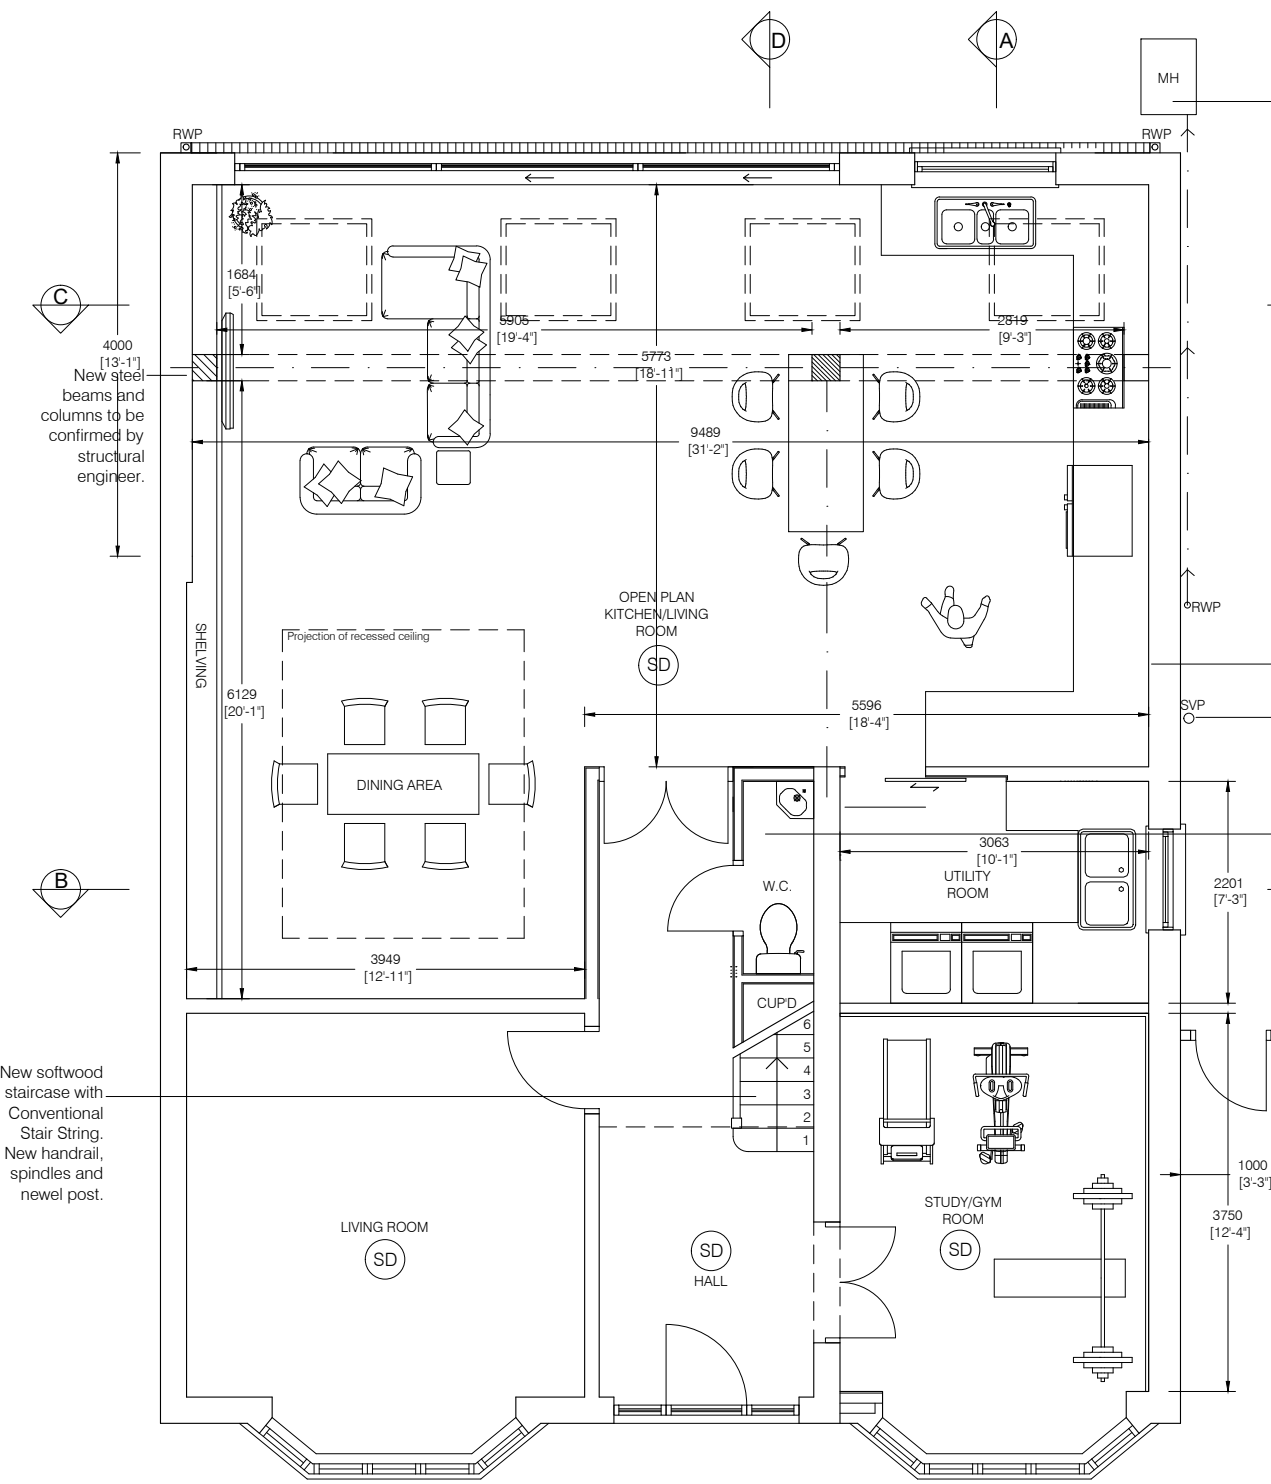
GROUND FLOOR PLAN

Provide LD1 Fire Alarm System to all habitable/circulation areas. Provide Smoke Detectors to all rooms and landings as indicated and Heat Detector in Kitchen. System to be on a separate circuit and have battery back up. Upgrade a escape window at 1st floor.

Update all doors to remaining habitable rooms to BCO requirements. If existing doors & frames are in a good condition it may be possible to coat them with fire paint or similar product.

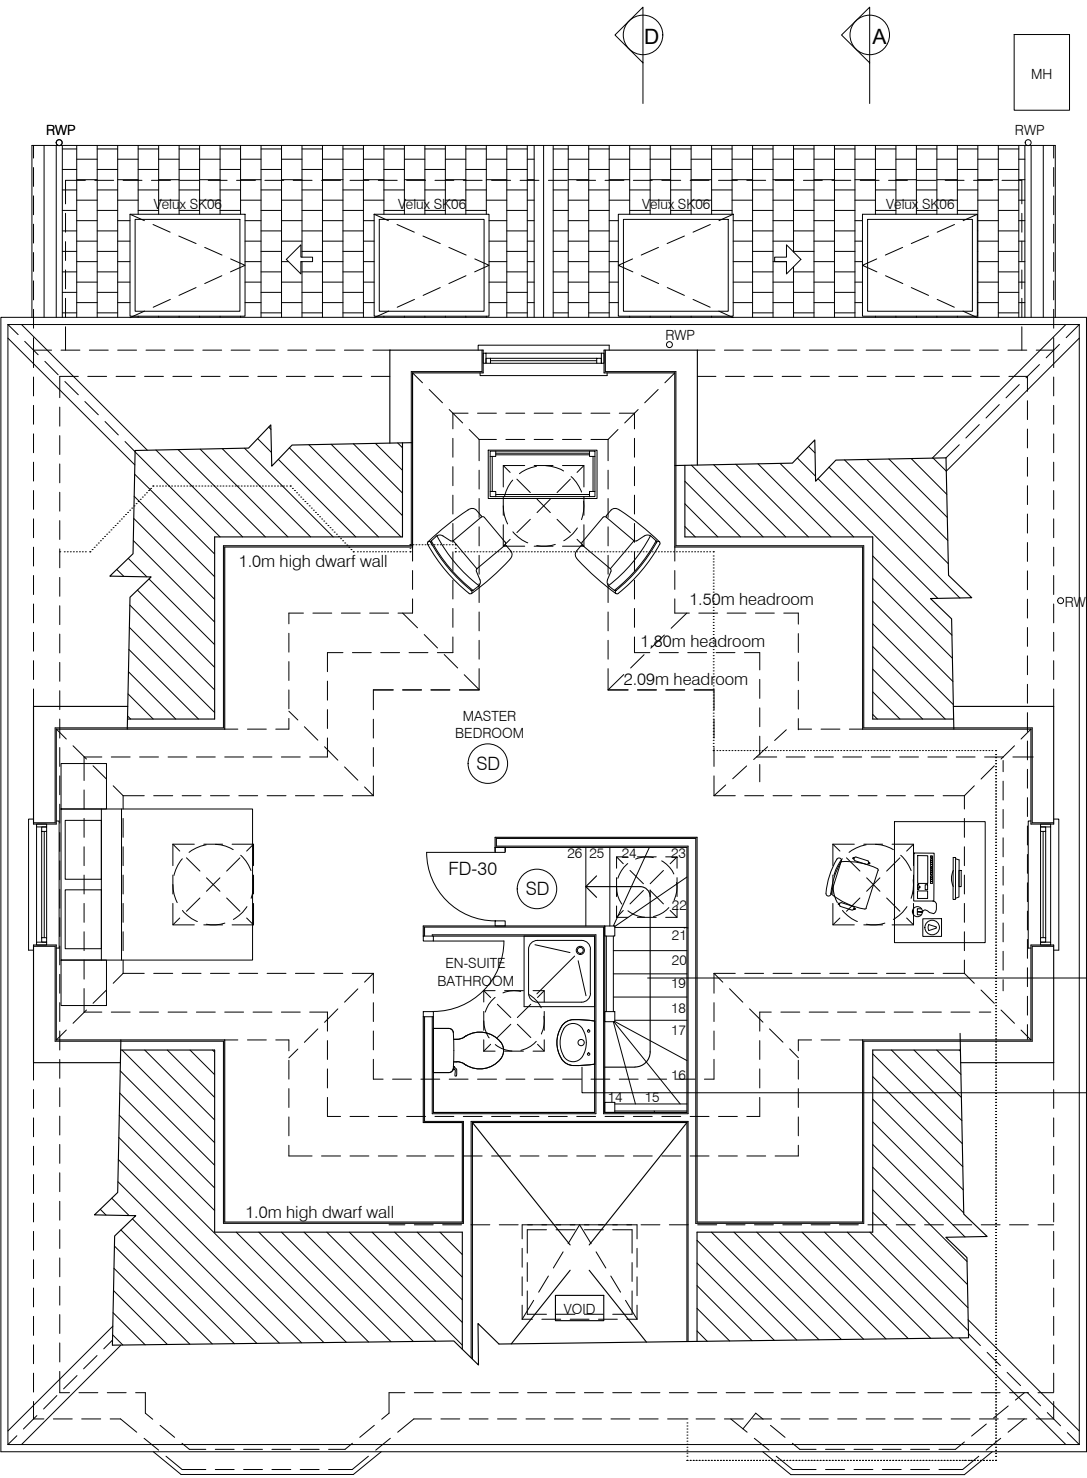
LOFT PLAN

Provide LD1 Fire Alarm System to all habitable/circulation areas. Provide Smoke Detectors to all rooms and landings as indicated and Heat Detector in Kitchen. System to be on a separate circuit and have battery back up. Upgrade a escape window at 1st floor.

Update all doors to remaining habitable rooms to BCO requirements. If existing doors & frames are in a good condition it may be possible to coat them with fire paint or similar product.

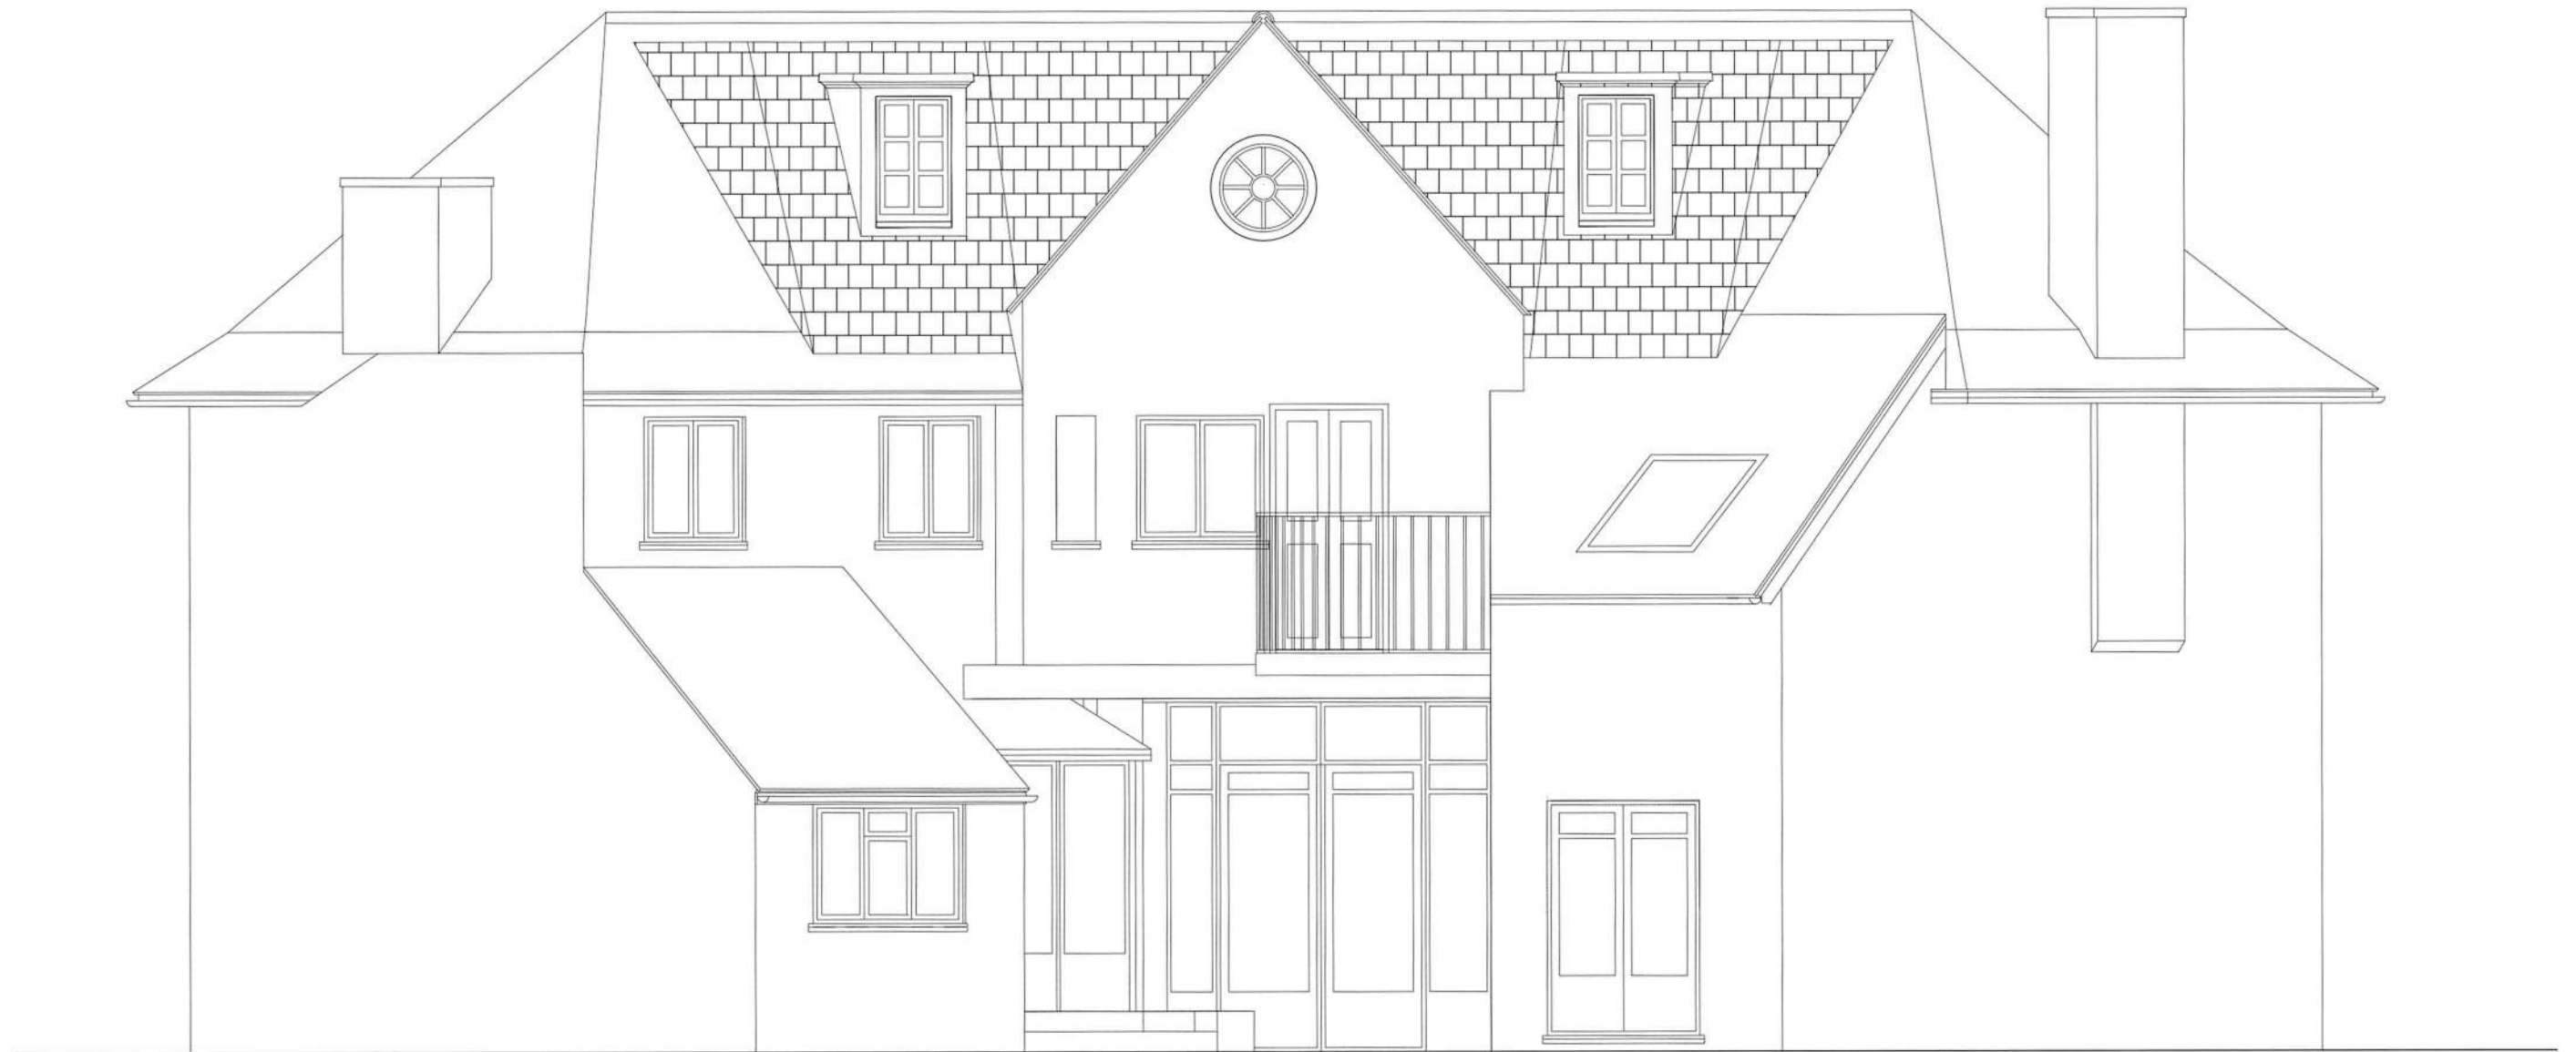
PROPOSED FLOOR PLANS

Conversion of roof space to habitable use to include four small dormer and a mansard. Ground floor extensions and internal changes in the first and ground floor.

Update all doors to remaining habitable rooms to BCO requirements.  
If existing doors & frames are in a good condition it may be possible to coat them with fire paint or similar product.
